# Manhole Inspection Summary

Manhole # S45EE\_050MH

Insp Date: **3/10/08 11:03 AM**

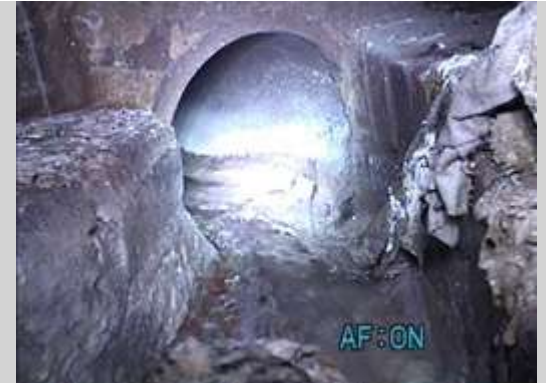
12 O'Clock Outflow

8 in. Circular Gravity Sewer  
Pipe Out @ 12 O'Clock

Pipe Height: **21.6** (in.) Rod and Bar (Angled)  
Pipe Material: **Clay** ☐ Pipe Lined  
Invert Depth: **11.25** (ft.) Flow Characteristics: **Fast**  
Deposits: ☒ None ☐ Mud ☐ Sludge ☐ Debris ☐ Grease  
Silt Depth: (in.) Deposits Extent:  
Infiltration: **None** Pipe Seal Cond: **Sound**
